Case Study: Thermography – Electrical Panel

SENERGY Consultants (P) Ltd

SCPL-CS-15

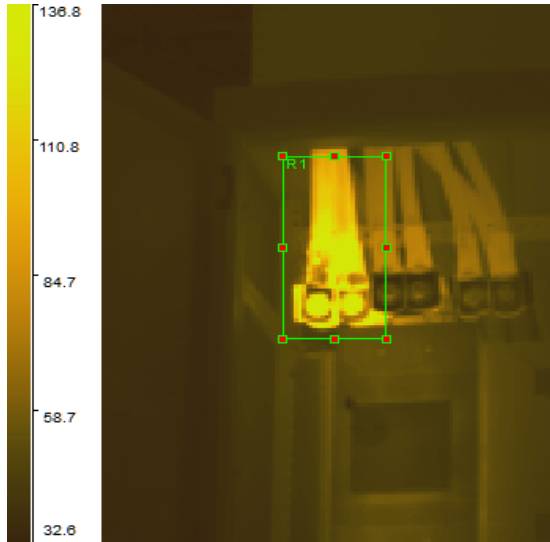
While conducting electrical & power quality audit for the pharmaceutical industry; the surface temperature of few of the electrical connections was observed to be very high.

The temperature should at the most be 15 °C above ambient, the temperature could be higher due to maintenance related issues including

- Loose connection
- Oxidation of the contact material
- Air gap between connection leading to higher resistance and hence heating of the material
- Deposition of foreign particles; leading to higher resistance
- Higher loading

The above concerns and issues were addressed by cleaning the affected connections.
